TECHNICAL NOTE

Ref: 579

Updating the firmware on 32-bit SD-Rack DAC cards (P16336 variant)

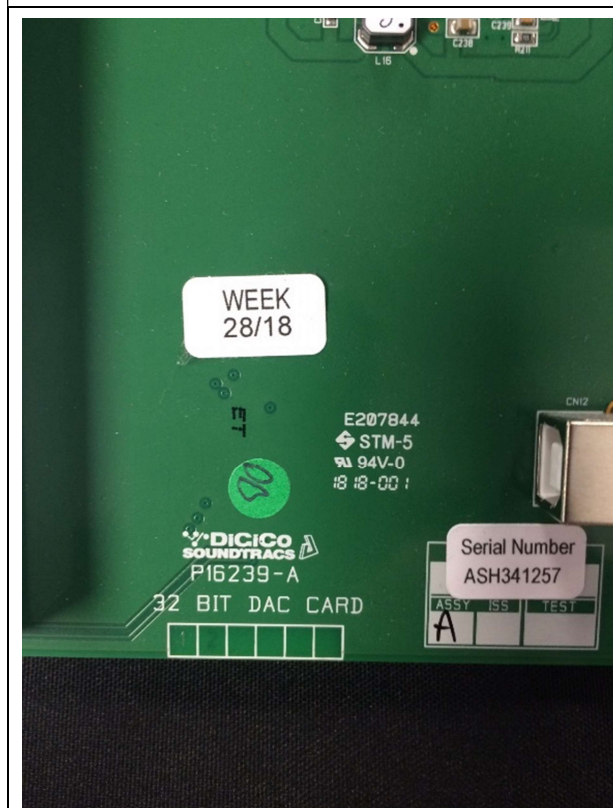
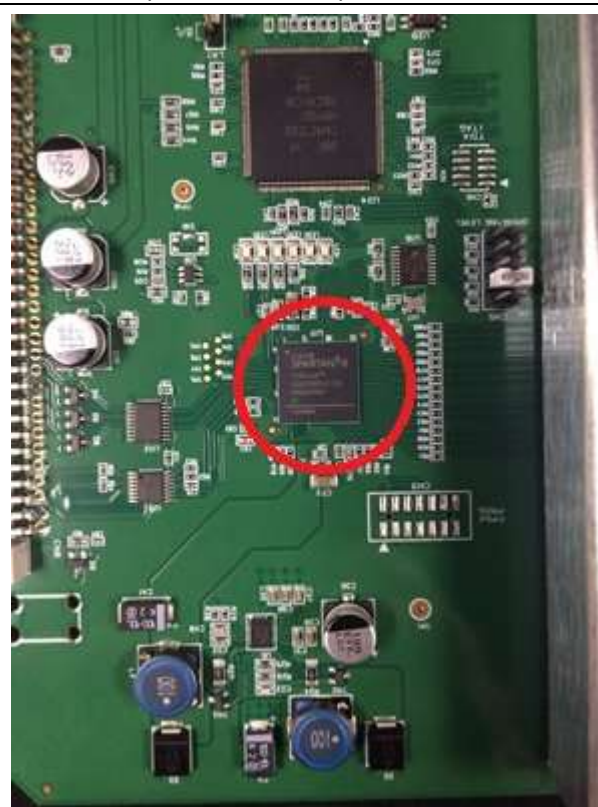
MOD-SDR-DAC32B with P16239 PCB and Spartan FPGA chip

Earlier 32-bit DAC cards use a Spartan FPGA chip, and the PCB board is part number P16239. The description printed on the card is '32 BIT DAC CARD' (see pictures below).

These cards are unaffected and DO NOT require any firmware update.

Flashing the card with the incorrect firmware will “break” the card and must be avoided. However, the card can be recovered by reprogramming it again with the correct firmware version. (see Appendix A)

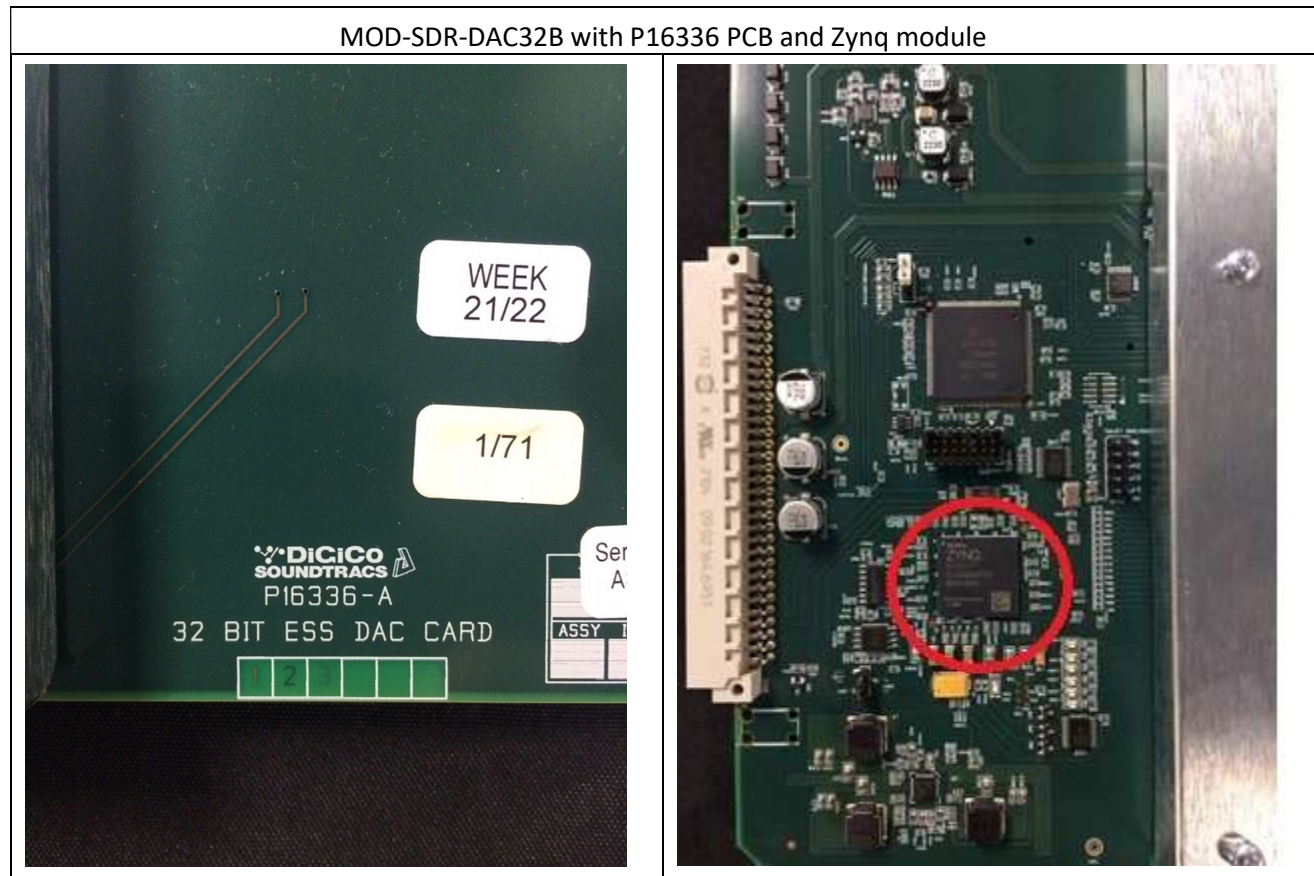
With certain card combinations in an SD-Rack it was found that the latest 32-bit DAC cards with Zynq firmware chip (P16336) don't always initialise correctly, and the slot is shown as empty in the Audio I/O window.

Later DAC cards (introduced from early 2022) use a Zynq chip, and the PCB board is part number P16336. The description printed on the card is '32 BIT ESS DAC CARD' (see pictures below).

A new firmware is available which will correct this.

The firmware update process described below is only intended for these cards.
